**ETHICON, INC.**

SEVEN YEAR DATA FOR TEN YEAR PROLENE™ STUDY: ERF 85-219

This report contains a summary of IR, IV, GPC, OM and SEM data supporting this study.

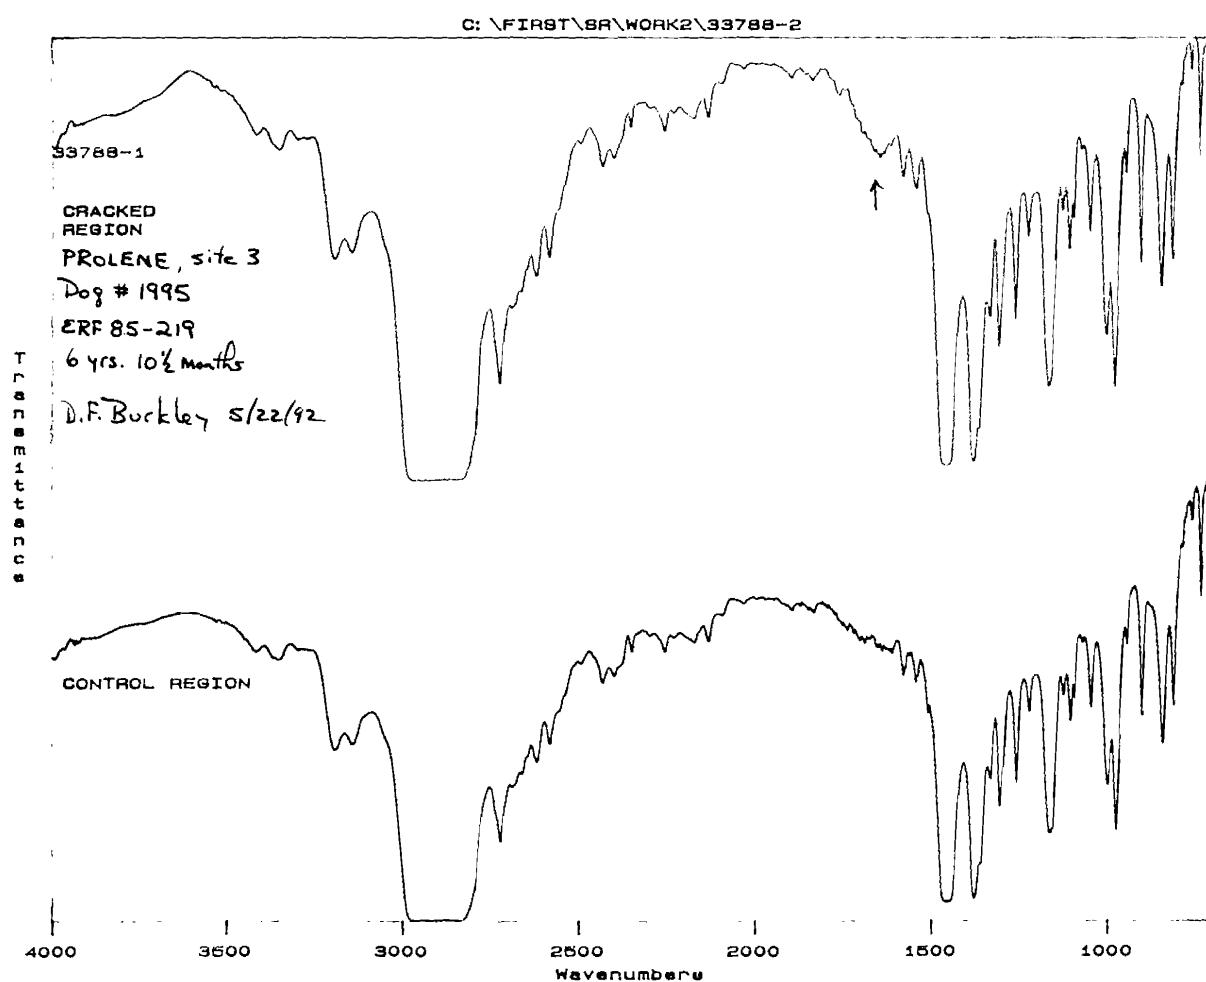
Figure A - Comparison IR Spectra of Cracked and Non-cracked Regions of PROLENE (SR33788)

IR microspectroscopy was used to examine cracked areas in ETHILON, Novafil and PROLENE™ explants. IR spectra obtained for cracked PROLENE specimens (Figure A) showed possible evidence of slight oxidation (a broadened weak absorbance at about 1650 cm<sup>-1</sup>). IR spectra obtained for cracked areas of ETHILON and Novafil did not differ from uncracked areas (Figures B and C), but expected IR absorbances for oxidation would be masked by the strong carbonyl absorbances normally observed for these sutures. Figures D and E show pictures of the areas examined by IR microspectroscopy for ETHILON and Novafil.

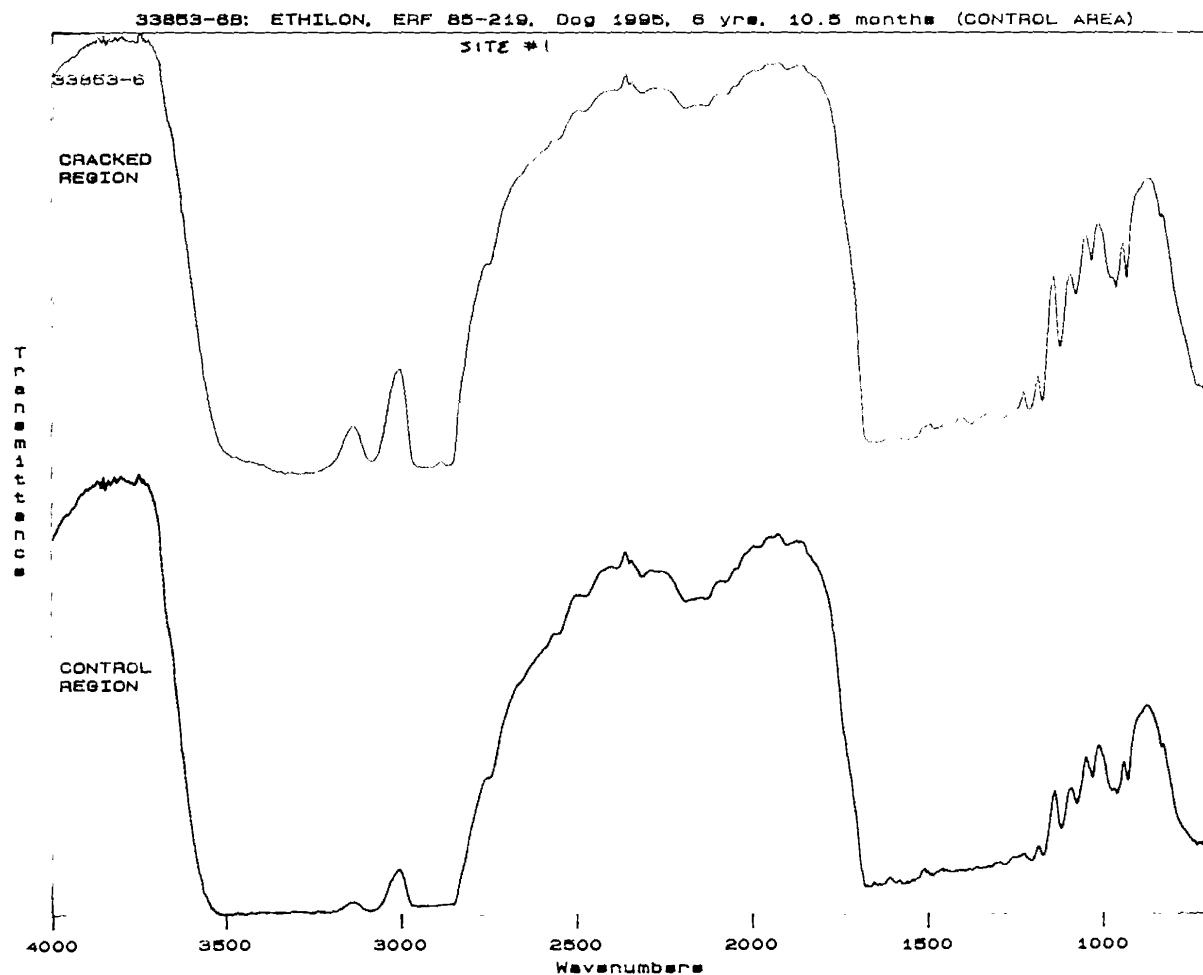
Figure B - Comparison IR Spectra of Cracked and Non-cracked Regions of ETHILON (SR33853)

IR spectra obtained from IR microspectroscopy show no differences when comparing cracked ETHILON with a "control" region of the same explant suture (a region that is not cracked or discolored). The same can be said for NOVAFIL as well. However, expected oxidation absorbancess associated with surface cracking would be masked by the ester carbonyl absorbancess inherent in these materials. Evidence of oxidation was observed for the PROLENE explant.

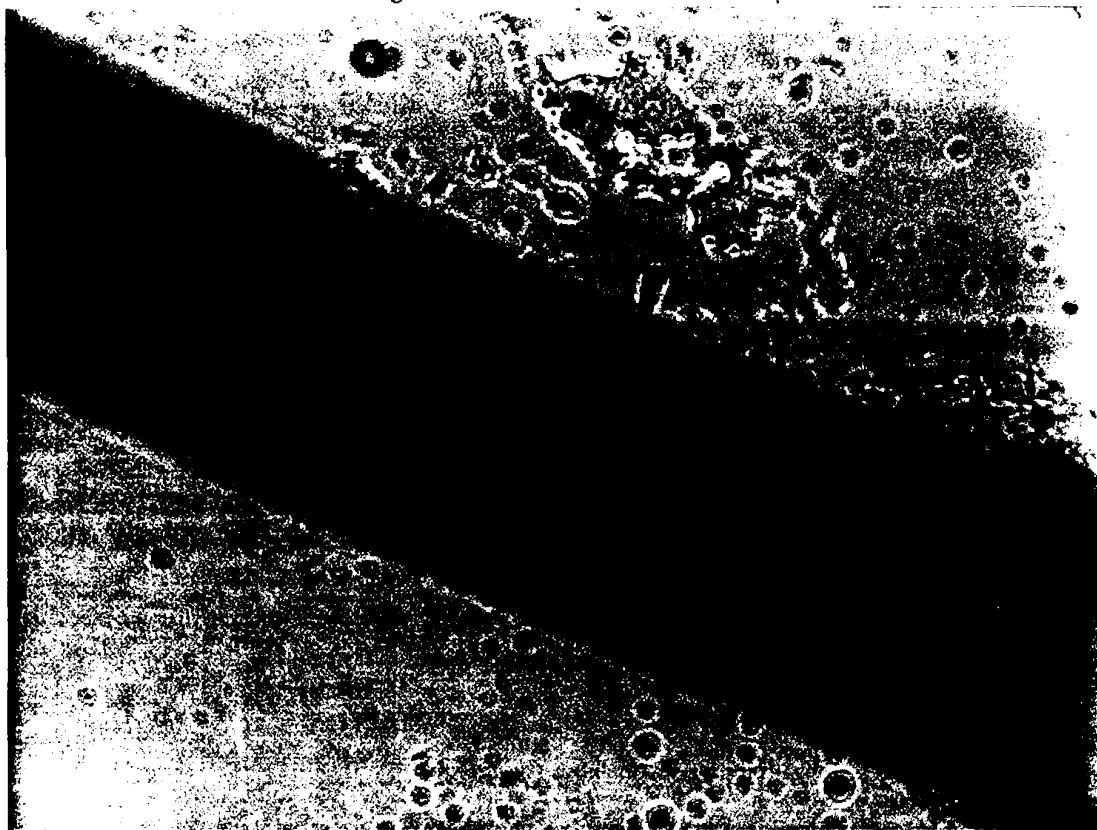
Figure 1A 7 Year Prolene Explants

In Figure 1A through 1D one area per site from each of the four dogs is shown in transmitted light. Out of seven sites cracking was found on PROLENE sutures from three sites. Notice the cracks observable through the still adhering tissue in Figure 1A in the suture from site 2.

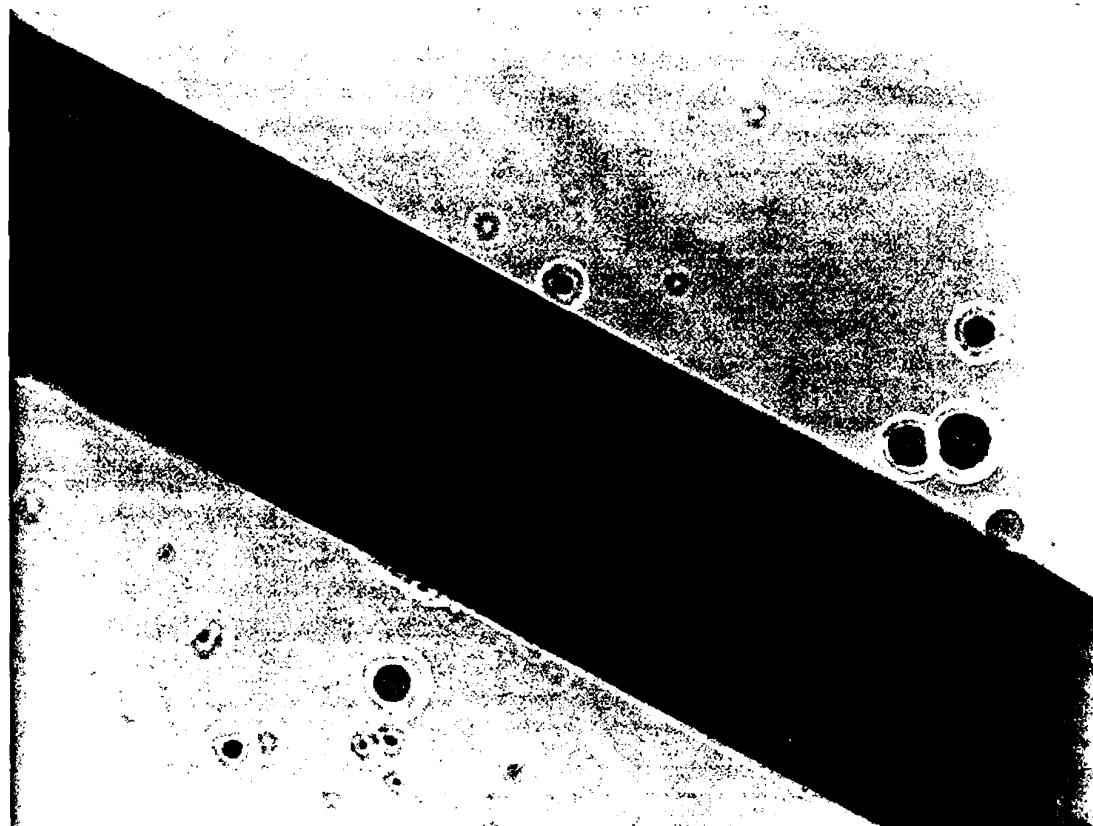
Figure 1 7 Year Prolene Explants

In Figure 1 and 2 SEM views of areas are shown after most of the tissue had been carefully removed. Again out of seven sites sutures from three sites had areas which showed cracking.

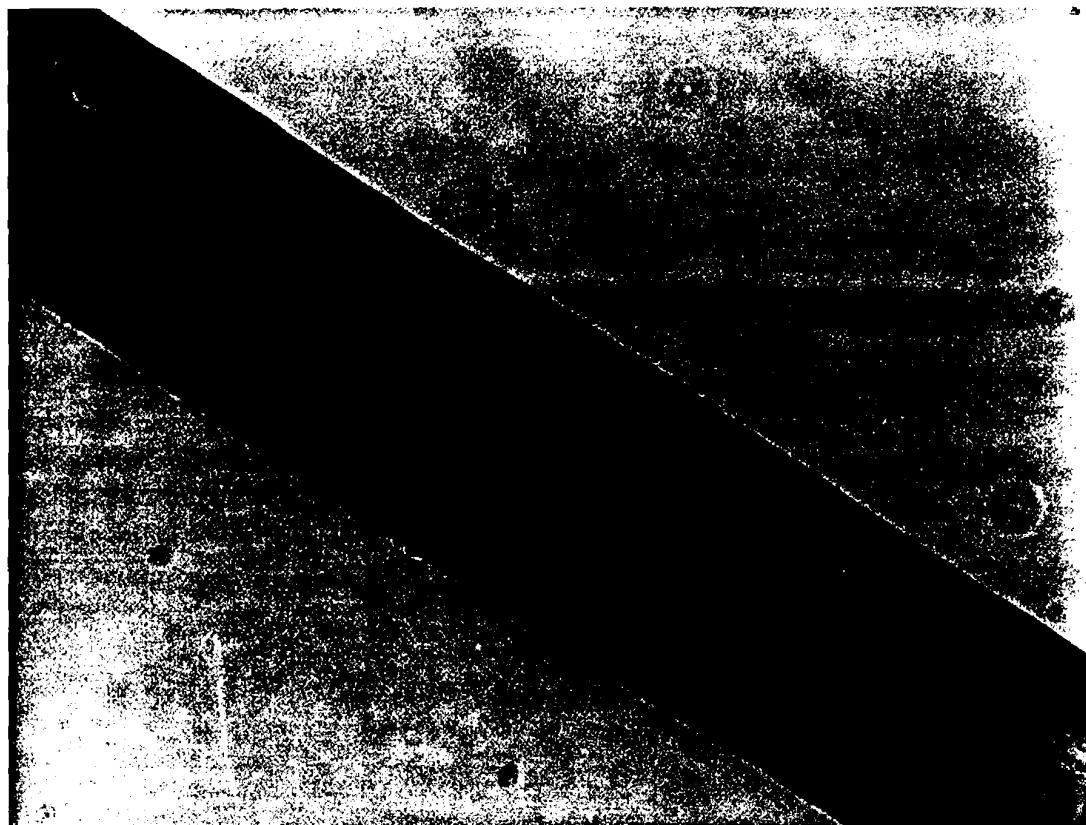
Figure 3A 7 Year Ethilon Explants

In Figure 3A through 3C sutures are shown from six different sites. Transmitted light allowed visualization of the differences between the intact dyed surface layer and the underlying colorless layers of the suture. In Figure 3A site 5 and Figure 3C site 3 the colorless area had not only lost its dyed surface layer but was abraded to such a degree that a decrease in suture diameter was found.

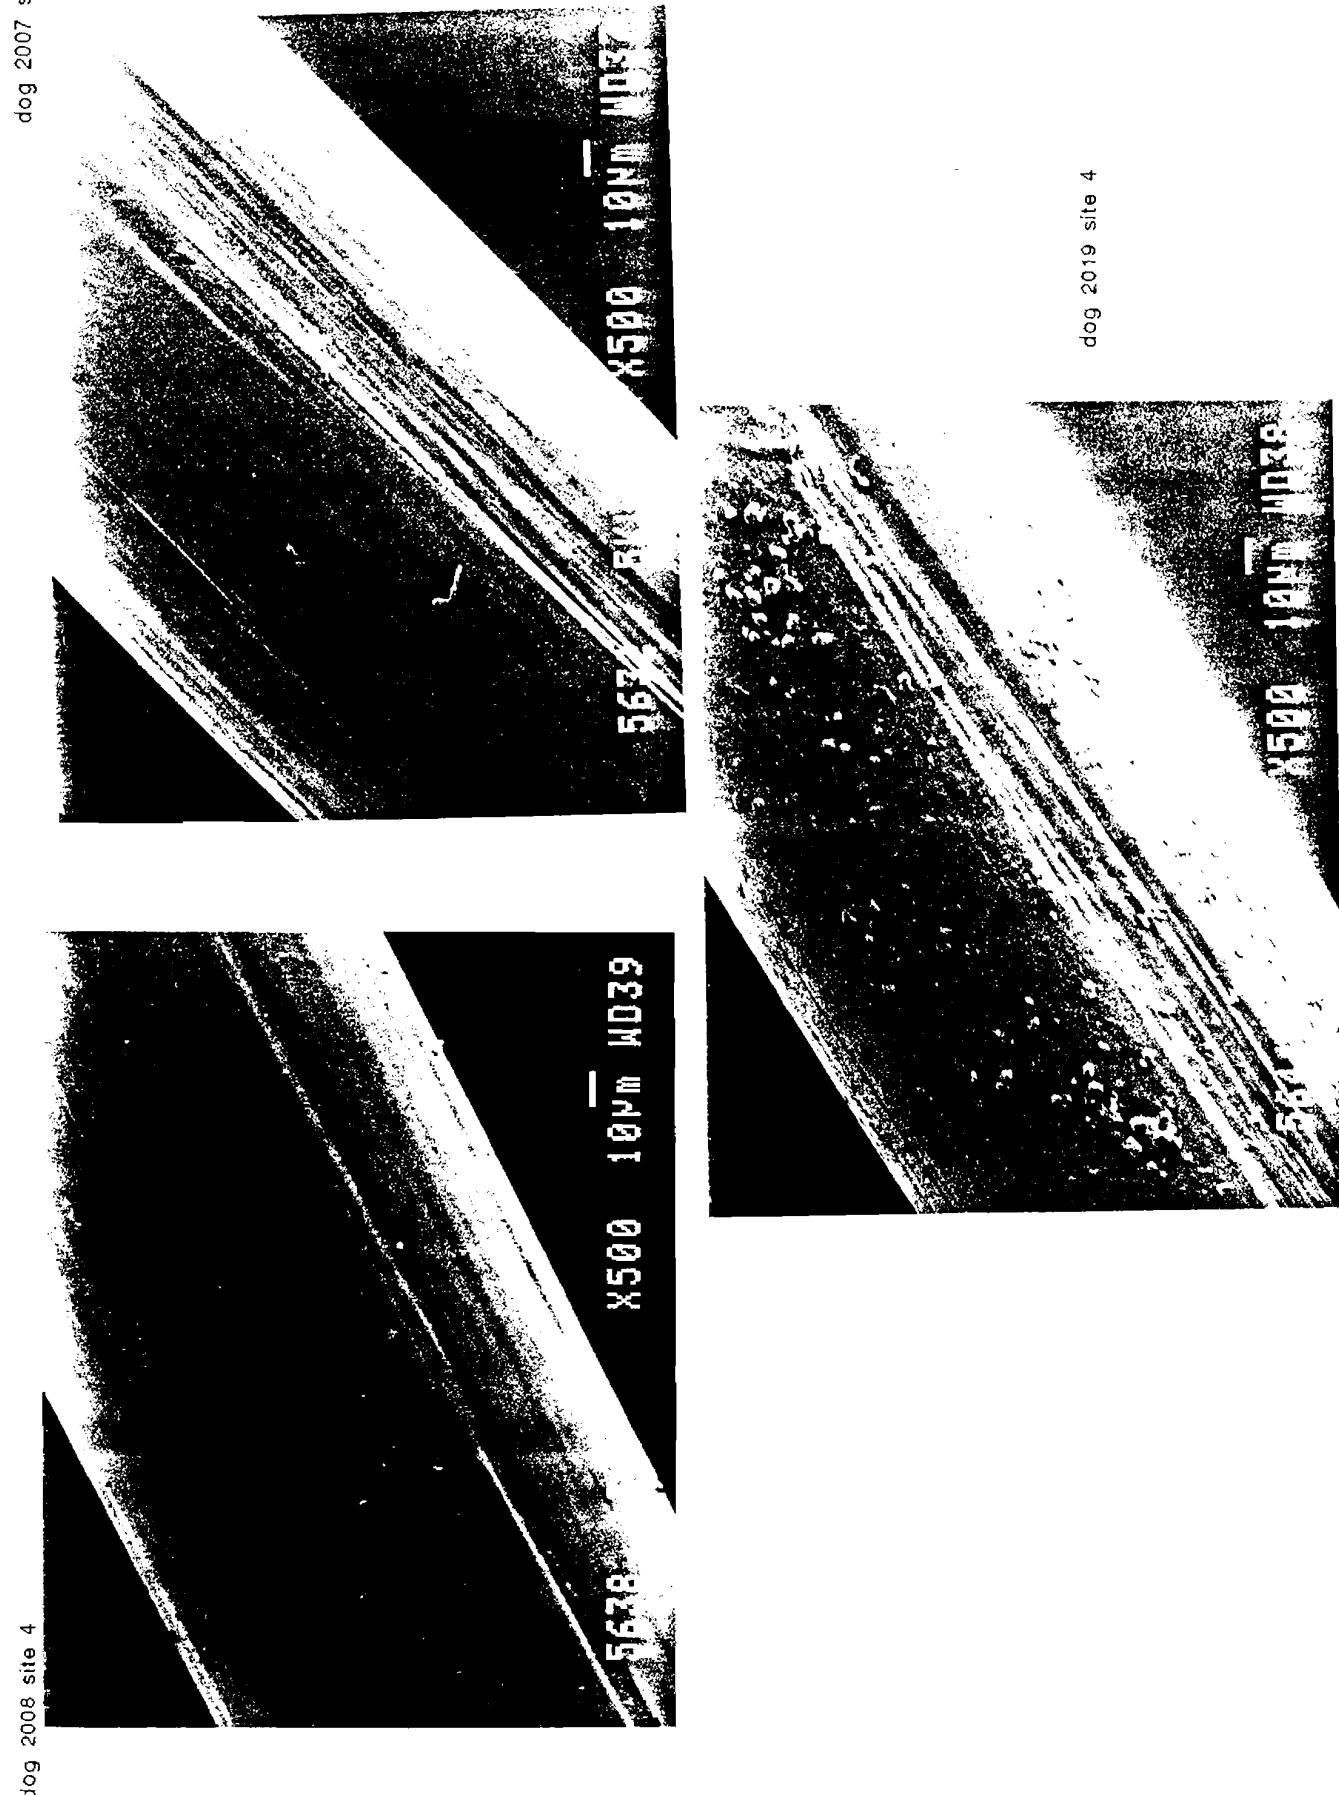
Figure 5 7 Year PVDF Explants

In Figures 5 and 6 the SEM examination of the PVDF sutures is shown. Only on the suture from one site (Figure 6 site 6) some cracks are found. The surfaces of the sutures from the other five sites show some striations which could be mechanical damage, otherwise the surfaces look intact. The contaminant on the site 4 (Figure 5) suture is tissue which had not been removed completely.

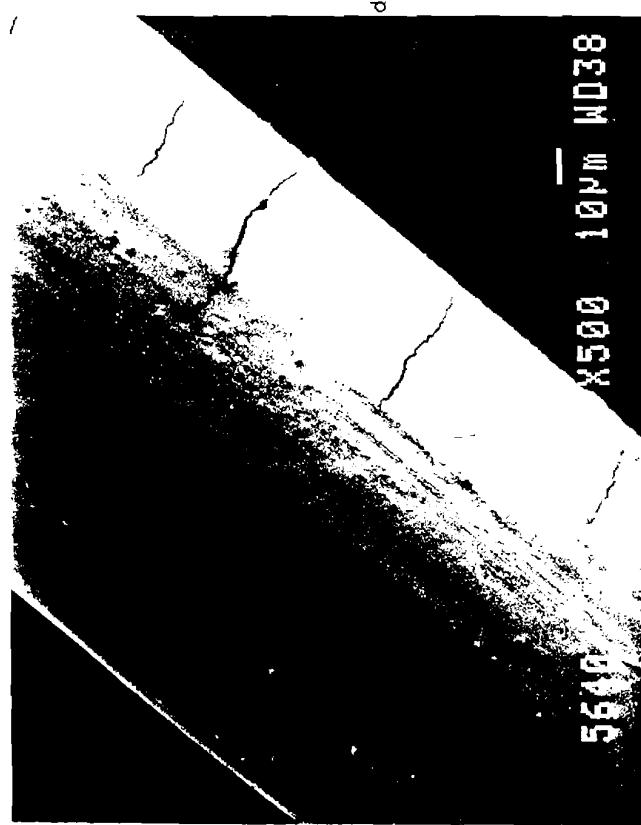
Figure 7A 7 Year Novafil Explants

Figure 7A through 7C show the Novafil sutures as observed with the light microscope. All surfaces from all sites look undamaged. Figure 7 and 8 show the SEM examination of these sutures. A few longitudinal scratches and cracks were found, see sites 1,2,3 (Figure 7,8). Also on the site 2 suture (Figure 8) still adhering tissue is found.
